THE NARROWS STREAM BANK RESTORATION AND PROTECTION PROJECT

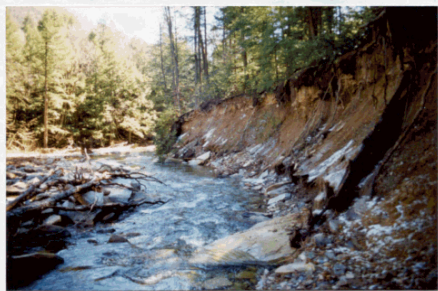
Conewago Creek, a tributary of the Susquehanna River is a high quality trout stream originating on South Mountain near the Appalachian Trail. However, sections of Conewago Creek just north of Arendtsville, Adams County, Pennsylvania were experiencing severe bank erosion, bank failure (collapse) and sediment deposition which was destroying aquatic habitat.

Upstream site 1 – Before the start of the project – February 1999

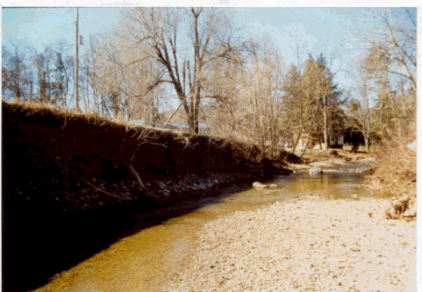
Downed trees in the stream, in turn, were causing additional bank erosion and channel scour by redirecting the flow towards the banks.

Downstream site 2 – Before the start of the project – February 1999

The near vertical eroding banks, which were approximately 15 feet high, were receding at rates approaching nearly 10 feet per year, generating over 8000 tons of sediment.

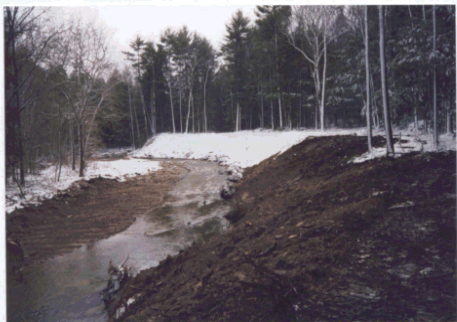
*Upstream Site 1 – After completion of the project
– March 1999*

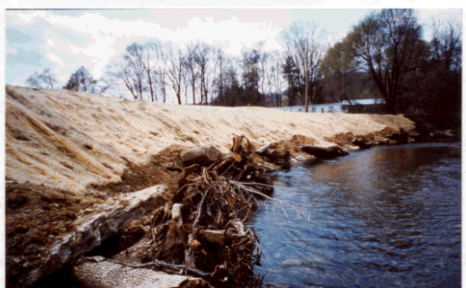
Downstream Site 2 – After completion of the project – March 1999

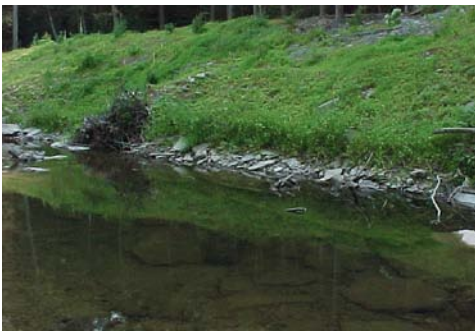
Upstream Site 1 – August 2001

Stream bank erosion rates and instream sedimentation have been greatly reduced with nearly 8000 tons of potential sediment prevented from entering the creek.

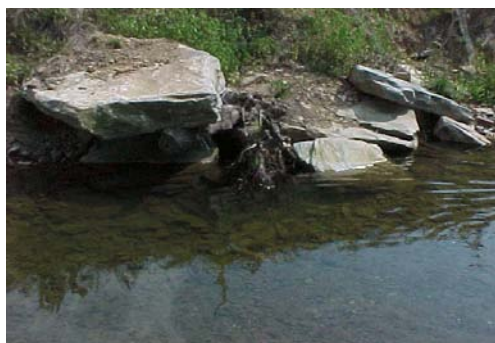
Downstream Site 2 – Close up of root wad, August 2001

Stream bottoms have returned to a clean gravel condition with no evidence of siltation. Native trees from natural successions have returned to the gravel bars on the opposite banks. In addition to stabilizing the streambanks, the rootwads are providing sheltered habitat to native trout that have returned to the restored areas in significant numbers.
